**MS4 General Permit**  
**Town of Wallingford 2021 Annual Report**  
 Permit Number GSM 00050  
 January 1, 2021 – December 31, 2021

**Town Of Wallingford**  
**2021 Annual Report**  
**MS4 System**

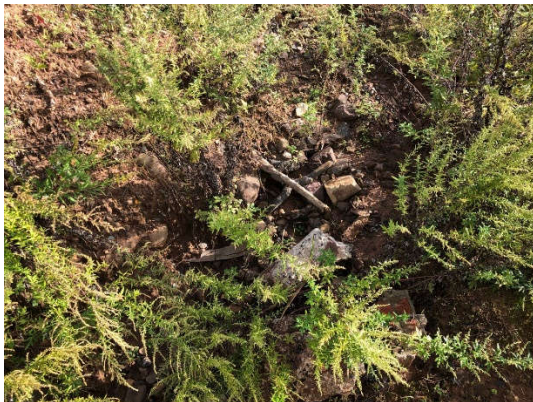
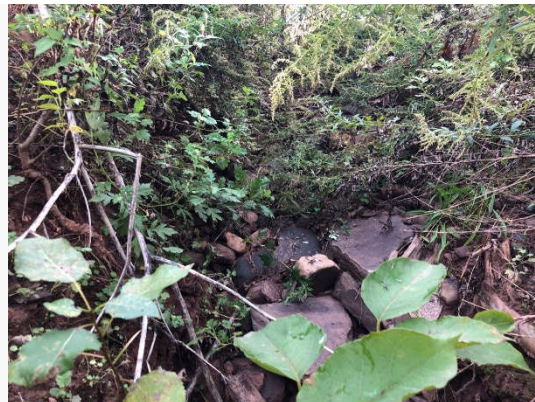
### Outfall:

Material	--
Subtype	--
Diameter	--
Condition	--
Erosion Control	--

Could not locate outfall. Outfall is in the discharge area of a scrapyard. Several swales that conjoin to one larger trench are in the approximate location of outfall. Trenches are highly eroded with rip rap lining the bottom

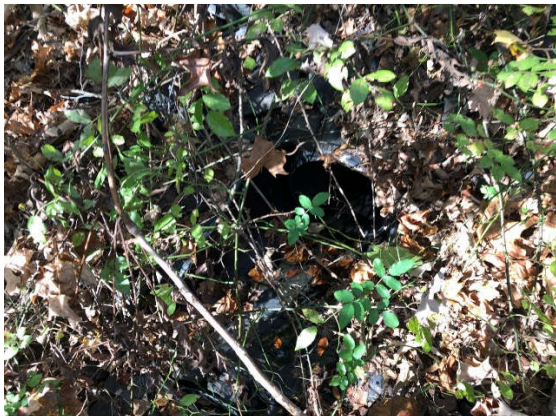
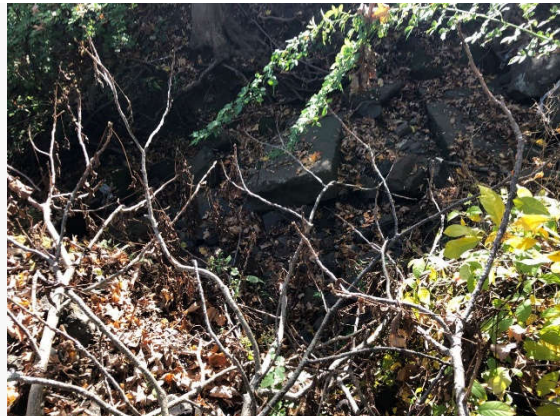
### Outfall:

Material	Plastic
Subtype	Flared End
Diameter	15"
Condition	Good
Erosion Control	Yes

Slightly overgrown, standing water in pipe, cut down debris thrown on top of outfall.

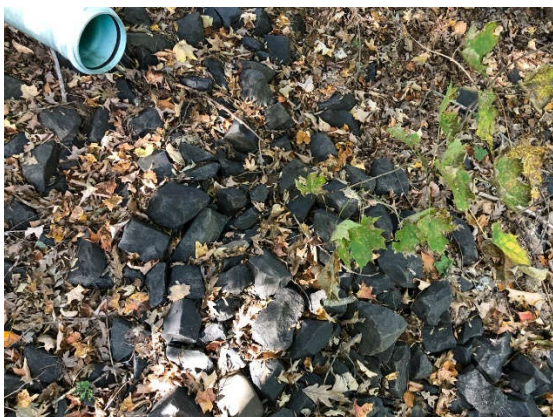
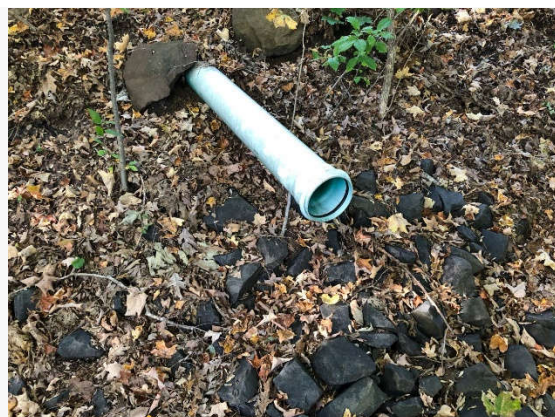
### Outfall:

Material	Plastic
Subtype	--
Diameter	6"
Condition	Excellent
Erosion Control	Yes

Outfall pipe is suspended but drainage lands on rip rap, little to no erosion, no trash or other debris.

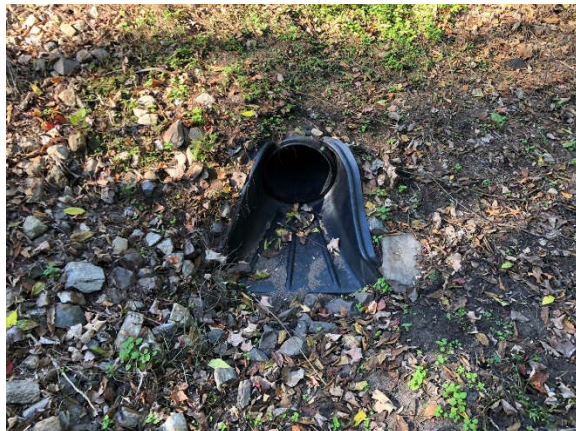
### Outfall:

Material	Plastic
Subtype	Flared End
Diameter	15"
Condition	Excellent
Erosion Control	Yes

Drains into a closed depression, minimal erosion, some rip rap

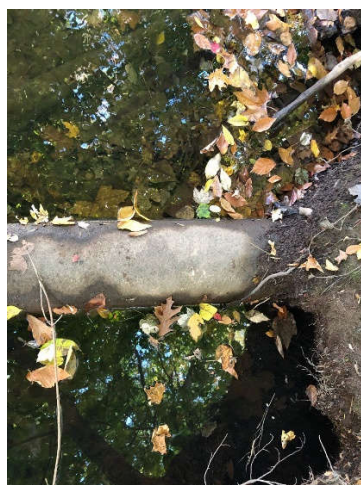
### Outfall:

Material	Concrete
Subtype	--
Diameter	12"
Condition	Good
Erosion Control	Unknown

Outfall goes directly into river, submerged under water, could not determine discharge or condition of opening.

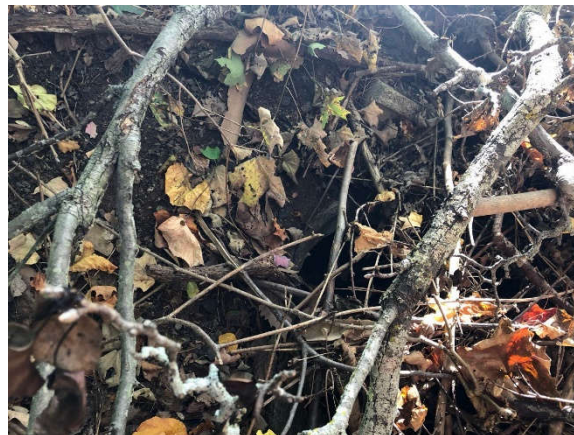
### Outfall:

Material	Concrete
Subtype	Flared End
Diameter	
Condition	Poor
Erosion Control	No

Completely blocked and covered by debris, some rip rap in discharge channel.

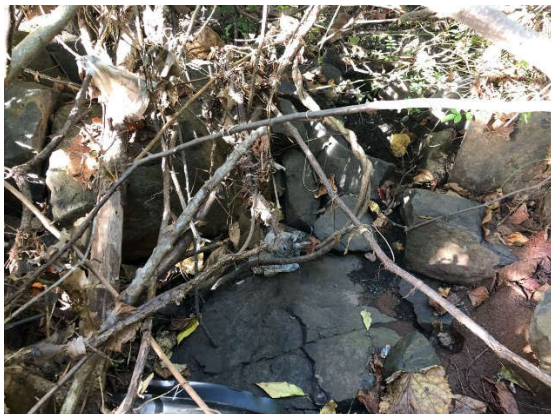
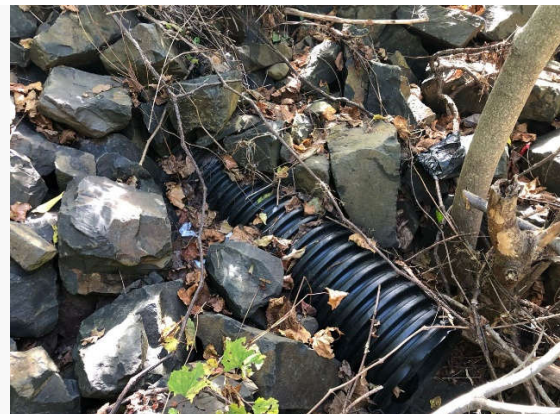
### Outfall:

Material	Plastic
Subtype	--
Diameter	15"
Condition	Good
Erosion Control	Yes

Slightly overgrown, trash present in discharge channel.

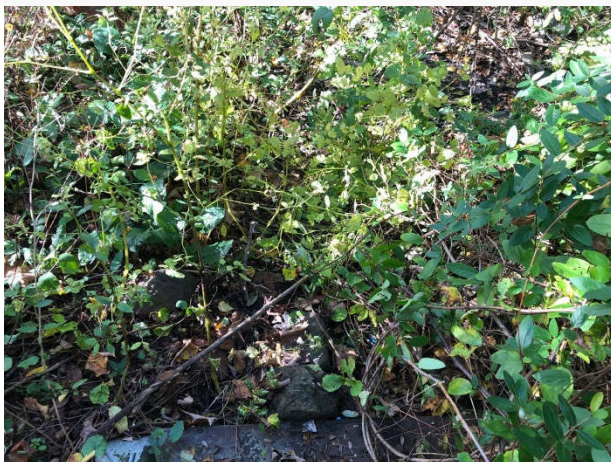
### Outfall:

Material	Plastic
Subtype	Flared End
Diameter	15"
Condition	Good
Erosion Control	Yes

Metal flared end on plastic, overgrown, some rip rap in discharge channel, minimal erosion

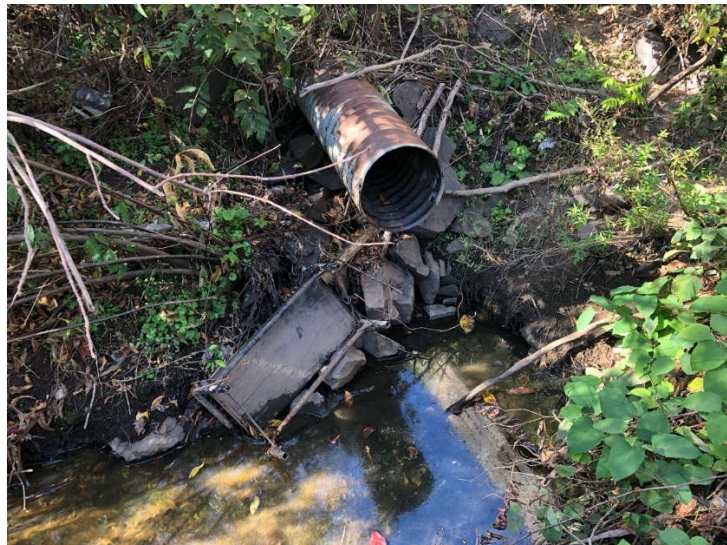
### Outfall:

Material	Metal
Subtype	--
Diameter	24"
Condition	Good
Erosion Control	No

Metal pipe, discharging directly into inlet stream, film on top of water at outfall, trash all along inlet stream.

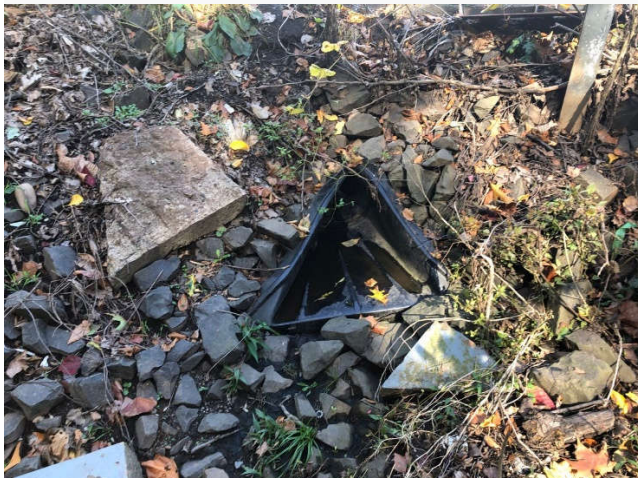
### Outfall:

Material	Concrete
Subtype	Flared End
Diameter	24"
Condition	Good
Erosion Control	Yes

Debris is opening of pipe likely to block water flow, rip rap in channel leading to river. Oily sheen on water at end of channel

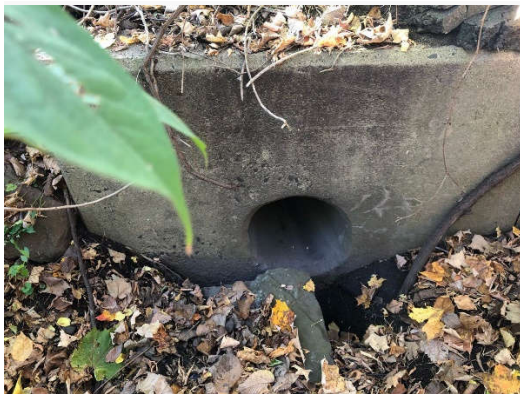
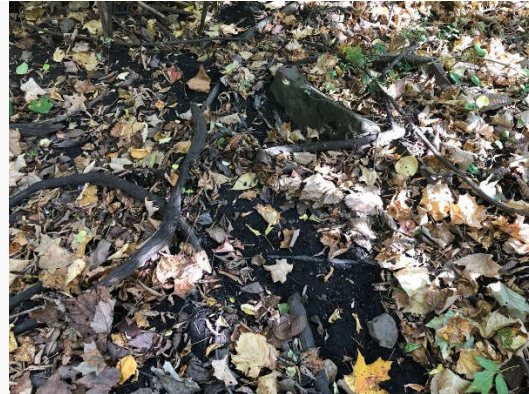
### Outfall:

Material	Concrete
Subtype	Other
Diameter	12"
Condition	Good
Erosion Control	Yes

Eroded sediment in front of outfall has caused a void where water goes rather than flow over rip rap and into river.

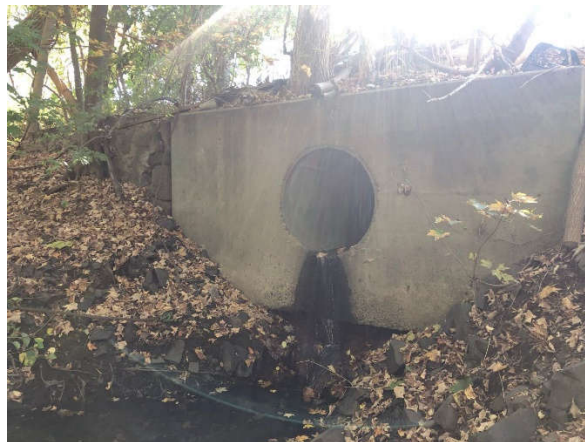
### Outfall:

Material	Concrete
Subtype	Other
Diameter	36"
Condition	Excellent
Erosion Control	No

Drains directly into river. Discharge present but was determined to be groundwater, clear and odorless.

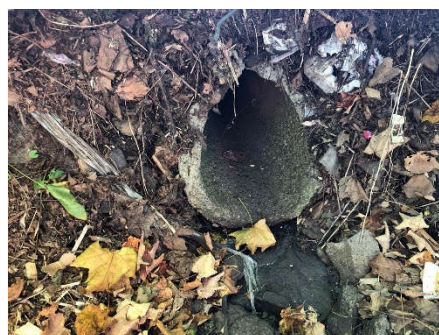
### Outfall:

Material	Concrete
Subtype	Flared End
Diameter	12"
Condition	Fair
Erosion Control	No

Eroded depression in front of outfall preventing water from flowing downhill, causing ponding. Rip rap present on hillside down to river.

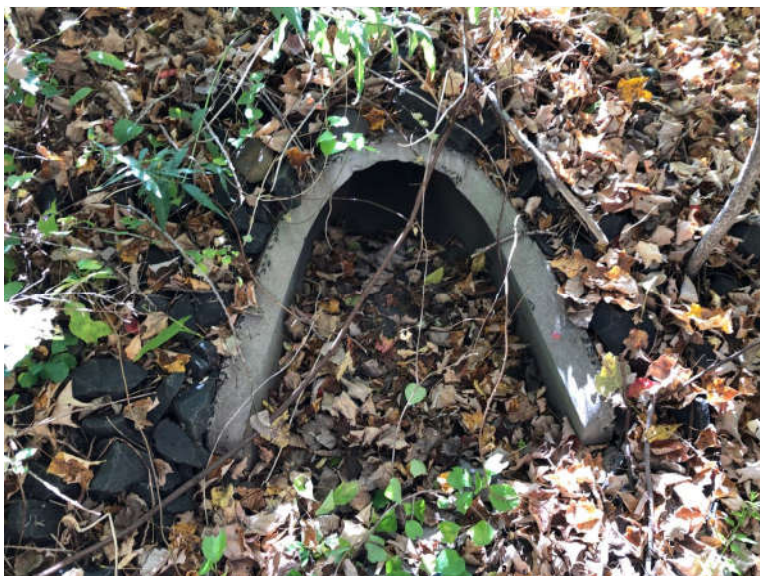
### Outfall:

Material	Concrete
Subtype	Flared End
Diameter	24"
Condition	Excellent
Erosion Control	Yes

Excellent condition, no erosion trash or sediment. Rip rap whole way down to river

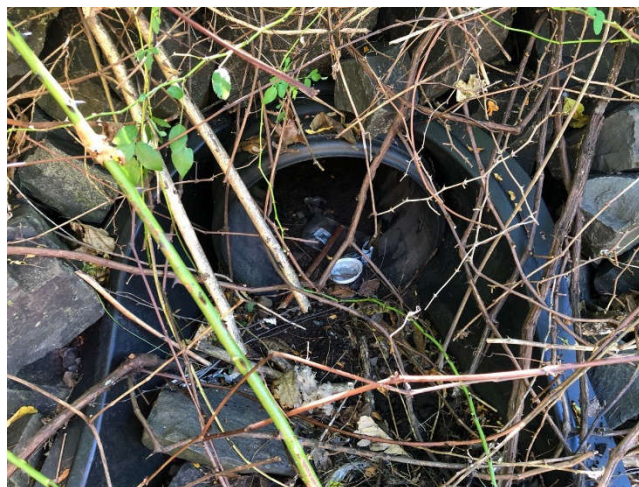
### Outfall:

Sediment accumulation in base and mouth of pipe, trash present, moderate vegetation, rip rap lining drainage area.

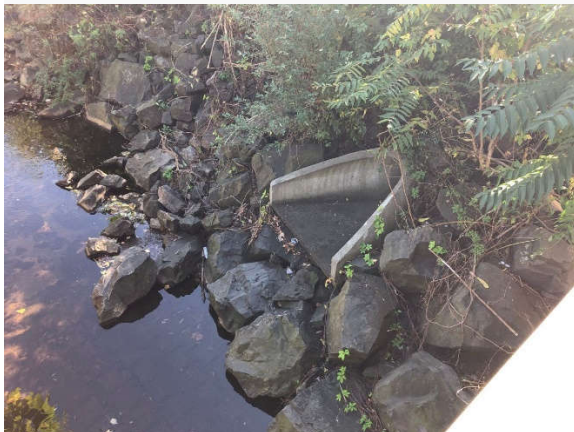
### Outfall:

Excellent condition, drains directly into stream, located directly across stream from OF-248,

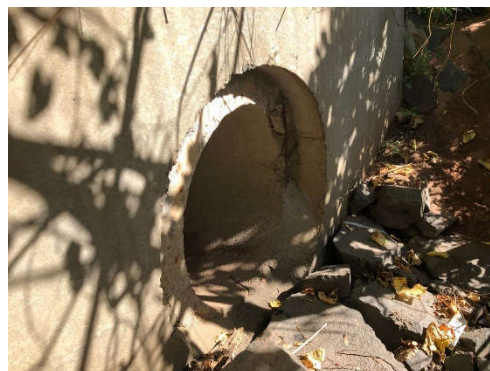
### Outfall:

Material	Precast
Subtype	
Diameter	24"
Condition	Excellent
Erosion Control	Yes

Excellent condition, located next to gas station, no erosion or trash, drains directly into river.

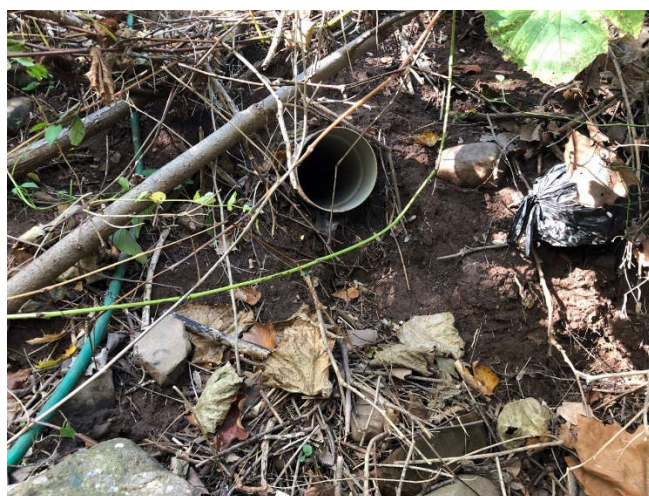
### Outfall:

Material	Plastic
Subtype	--
Diameter	6"
Condition	Good
Erosion Control	No

Plastic pipe, water falls out onto exposed soil and has moderately eroded discharge channel, some trash present, moderate vegetation, located behind gas station and liquor store.

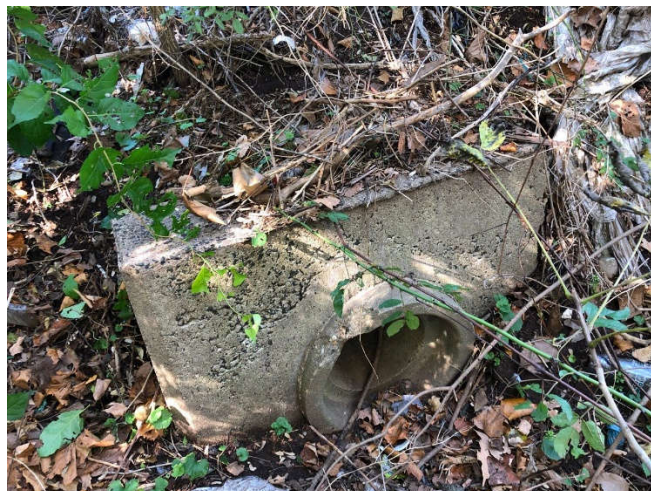
### Outfall:

Material	Precast
Subtype	
Diameter	12"
Condition	Good
Erosion Control	No

Outfall pipe in excellent condition, trash present in discharge channel, located behind gas station and liquor store. No erosion controls in place, channel is moderately eroded down to the river.

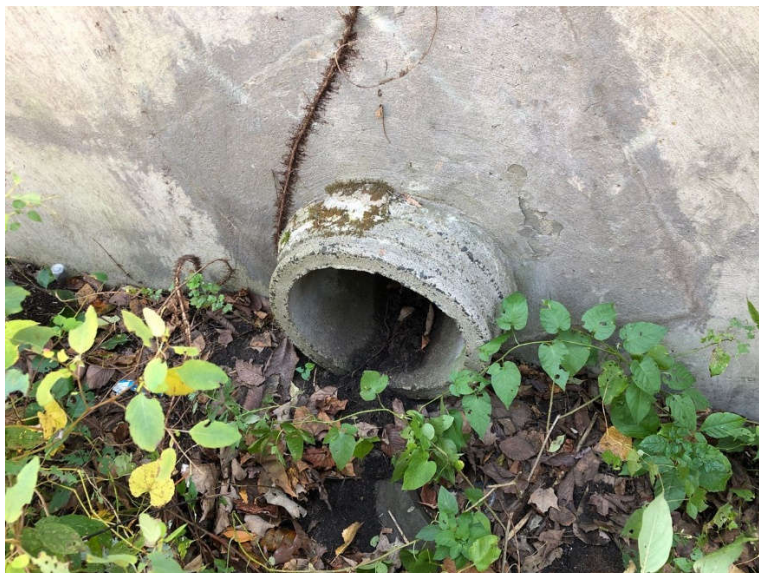
### Outfall:

Material	Precast
Subtype	Other
Diameter	15"
Condition	Excellent
Erosion Control	Yes

Excellent condition, minimal vegetation, rip rap leading down to river, no erosion.

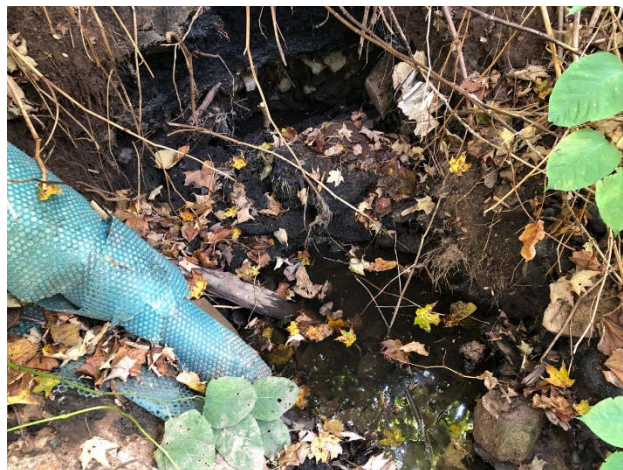
### Outfall:

Material	--
Subtype	--
Diameter	--
Condition	Poor
Erosion Control	Yes

Outfall is completely blocked, cannot determine material or diameter, by overlying asphalt collapse. Standing water present, trash also present around outfall. Rip rap places along discharge channel leading to river, minimal channel erosion.

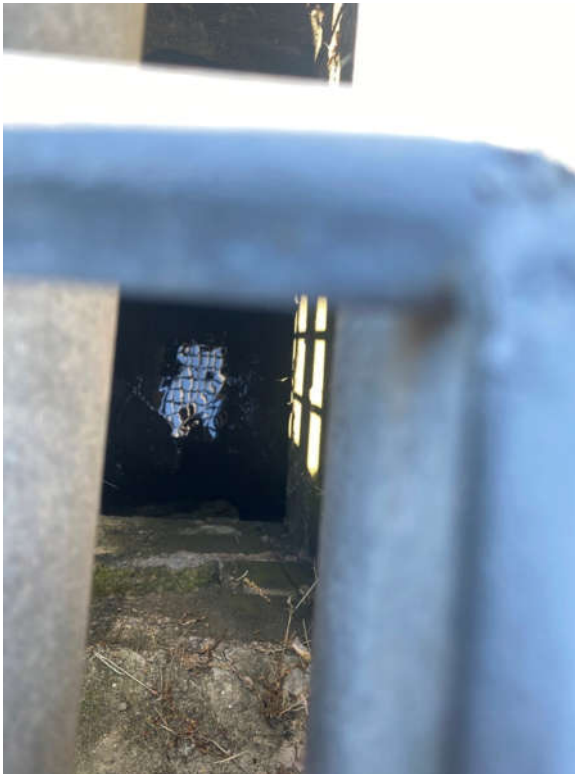
IC-11	CTDOT	5/17/2021	Unk.	Good	Good	Good condition, no discharge.	No	-72.81997544	41.49142214
IC-10	CTDOT	5/17/2021	Unk.	Poor	Poor	CB heavily silted in; vegetation growing inside CB	No	-72.82250208	41.49196862
IC-9	CTDOT	5/17/2021	Unk.	Good	Good	Good condition, no discharge.	No	-72.82322628	41.49205702
IC-8	CTDOT	5/17/2021	Unk.	Excellent	Good	Good condition, no discharge.	No	-72.82421333	41.49213738
IC-7	CTDOT	5/17/2021	Unk.	Good	Good	Good condition, no discharge.	No	-72.82724959	41.49229409
IC-6	CTDOT	5/17/2021	Unk.	Good	Fair	Some sediment in CB.	No	-72.82860142	41.49257536
IC-5	CTDOT	5/17/2021	Unk.	--	--	Unable to open manhole.	--	-72.82965821	41.49264769
IC-4	CTDOT	5/17/2021	Unk.	Good	Poor	Slight discharge coming from W, along state road, not MS4. Next in-line MS4 CB heavily silted in.	Yes	-72.83134801	41.49252313
IC-3	CTDOT	5/17/2021	Unk.	Good	Good	Good condition, no discharge.	No	-72.83499581	41.49292896

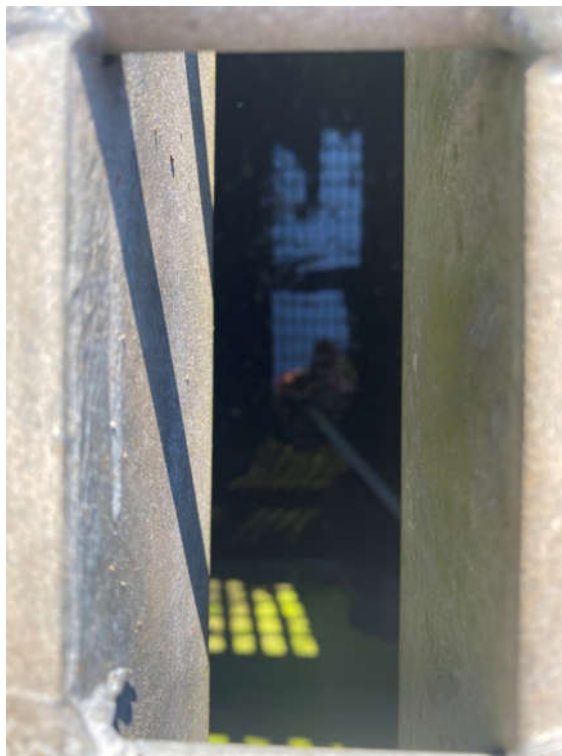
Interconnection ID	MS4	Inspection Date	Material	Condition	Erosion Control	Notes	Discharge	Longitude	Latitude
IC-21	CTDOT	5/17/2021	Unk.	Good	Good	Good condition, no discharge. Some trash/debris present.	No	-72.83775044	41.45765206
IC-20	CTDOT	5/17/2021	Unk.	Good	Fair	Some grass clippings in CB.	No	-72.82897425	41.47793953
IC-13	CTDOT	6/7/2021	Concrete	Good	Excellent	Good condition, no discharge.	No	-72.80576778	41.48488412
IC-14	CTDOT	6/7/2021	Concrete	Good	Good	Good condition, no discharge.	No	-72.80165863	41.48300739
IC-16	CTDOT	6/7/2021	Unk.	Poor	Poor	Last 2 CBs on Thorpe Ave completely silted in. No interconnection possible.	No	-72.76756239	41.47972799
IC-17	CTDOT	6/7/2021	Concrete	Good	Good	Good condition, no discharge.	No	-72.76628566	41.478884
IC-18	CTDOT	6/7/2021	Concrete	Good	Good	Some trash around CB.	No	-72.76505185	41.47676996
IC-15	CTDOT	6/7/2021	Unk.	Good	Fair	Trash/debris around CB.	No	-72.78639418	41.48340524

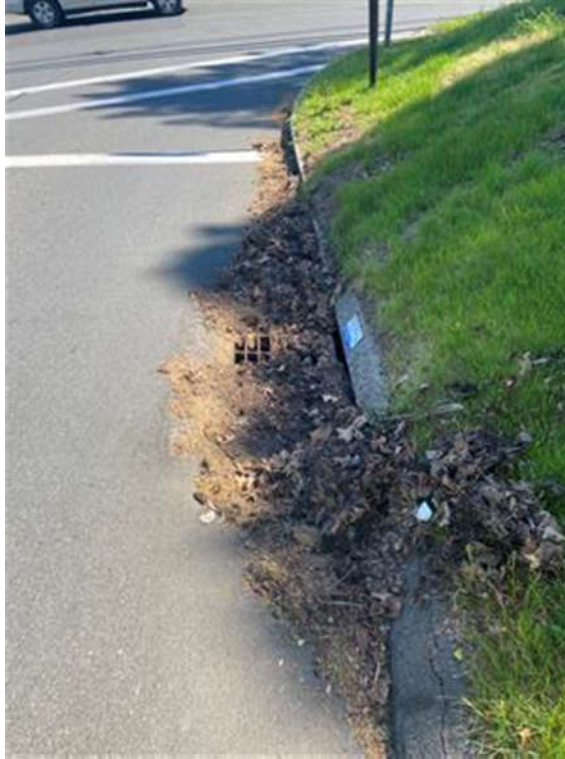
IC-23	CTDOT	5/17/2021	Unk.	Fair	Good	CB partially filled with sediment/leaf debris.	No	-72.80481023	41.44061565
IC-22	CTDOT	5/17/2021	Unk.	Fair	Fair	CB covered with leaf debris	No	-72.80537886	41.44828399
IC-19	CTDOT	6/7/2021	Unk.	Excellent	Good	Inspection completed at last in-line CB on Tammy Hill Rd. Good condition, no discharge. Homeowner had placed garbage cans directly on CB.	No	-72.75116873	41.47071684
IC-25	CTDOT	5/17/2021	Unk.	Good	Good	Good condition, no discharge.	No	-72.80930829	41.49615546
IC-26	CTDOT	5/17/2021	Unk.	Good	Good	Good condition, no discharge.	No	-72.80940485	41.49569741
IC-27	CTDOT	5/17/2021	Unk.	Fair	Fair	Trash/debris in area of CB.	No	-72.80920101	41.49086762
IC-12	CTDOT	5/17/2021	Unk.	Good	Good	Good condition, no discharge.	No	-72.81129313	41.48827176
IC-29	Meriden/CTDOT	6/7/2021	Concrete	Fair	Good	Good condition, no discharge.	No	-72.76441933	41.49692016
