NOTICE OF VIOLATION

Re: 950 South Colony Road – 1NRSJ, LLC –carwash facility – (filling)

ENVIRONMENTAL PLANNER'S REPORT

**ANALYSIS OF 50' WETLAND BUFFER AREA FILLING AT
1NRSJ,LLC - CARWASH FACILITY 950 SOUTH COLONY ROAD**

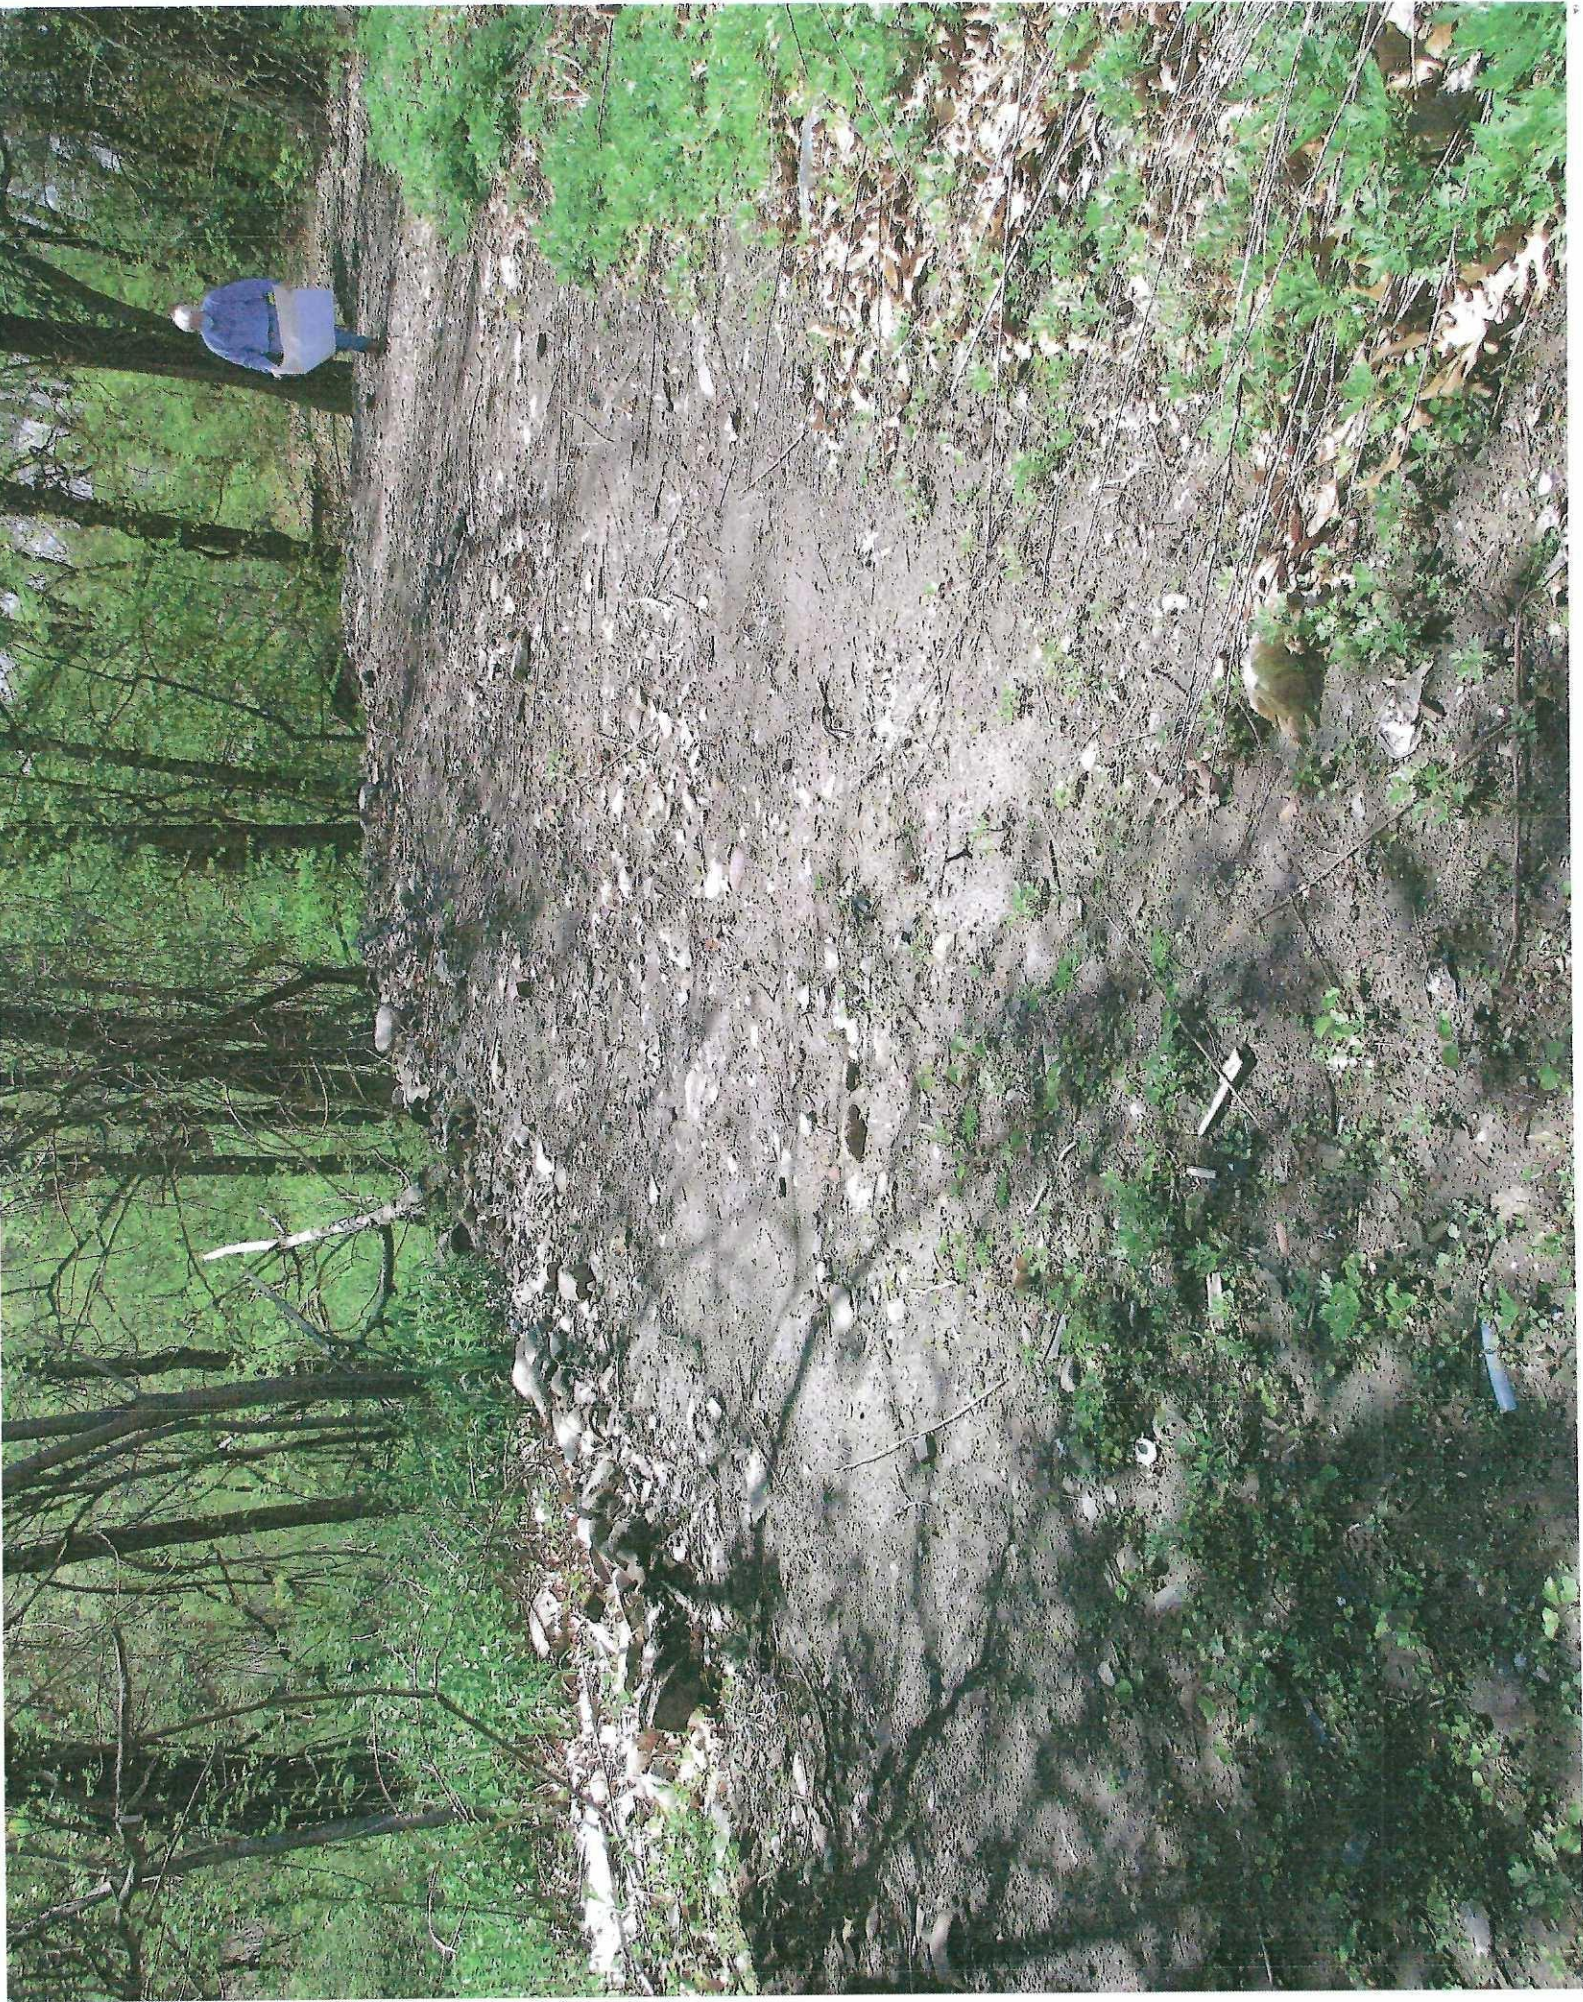
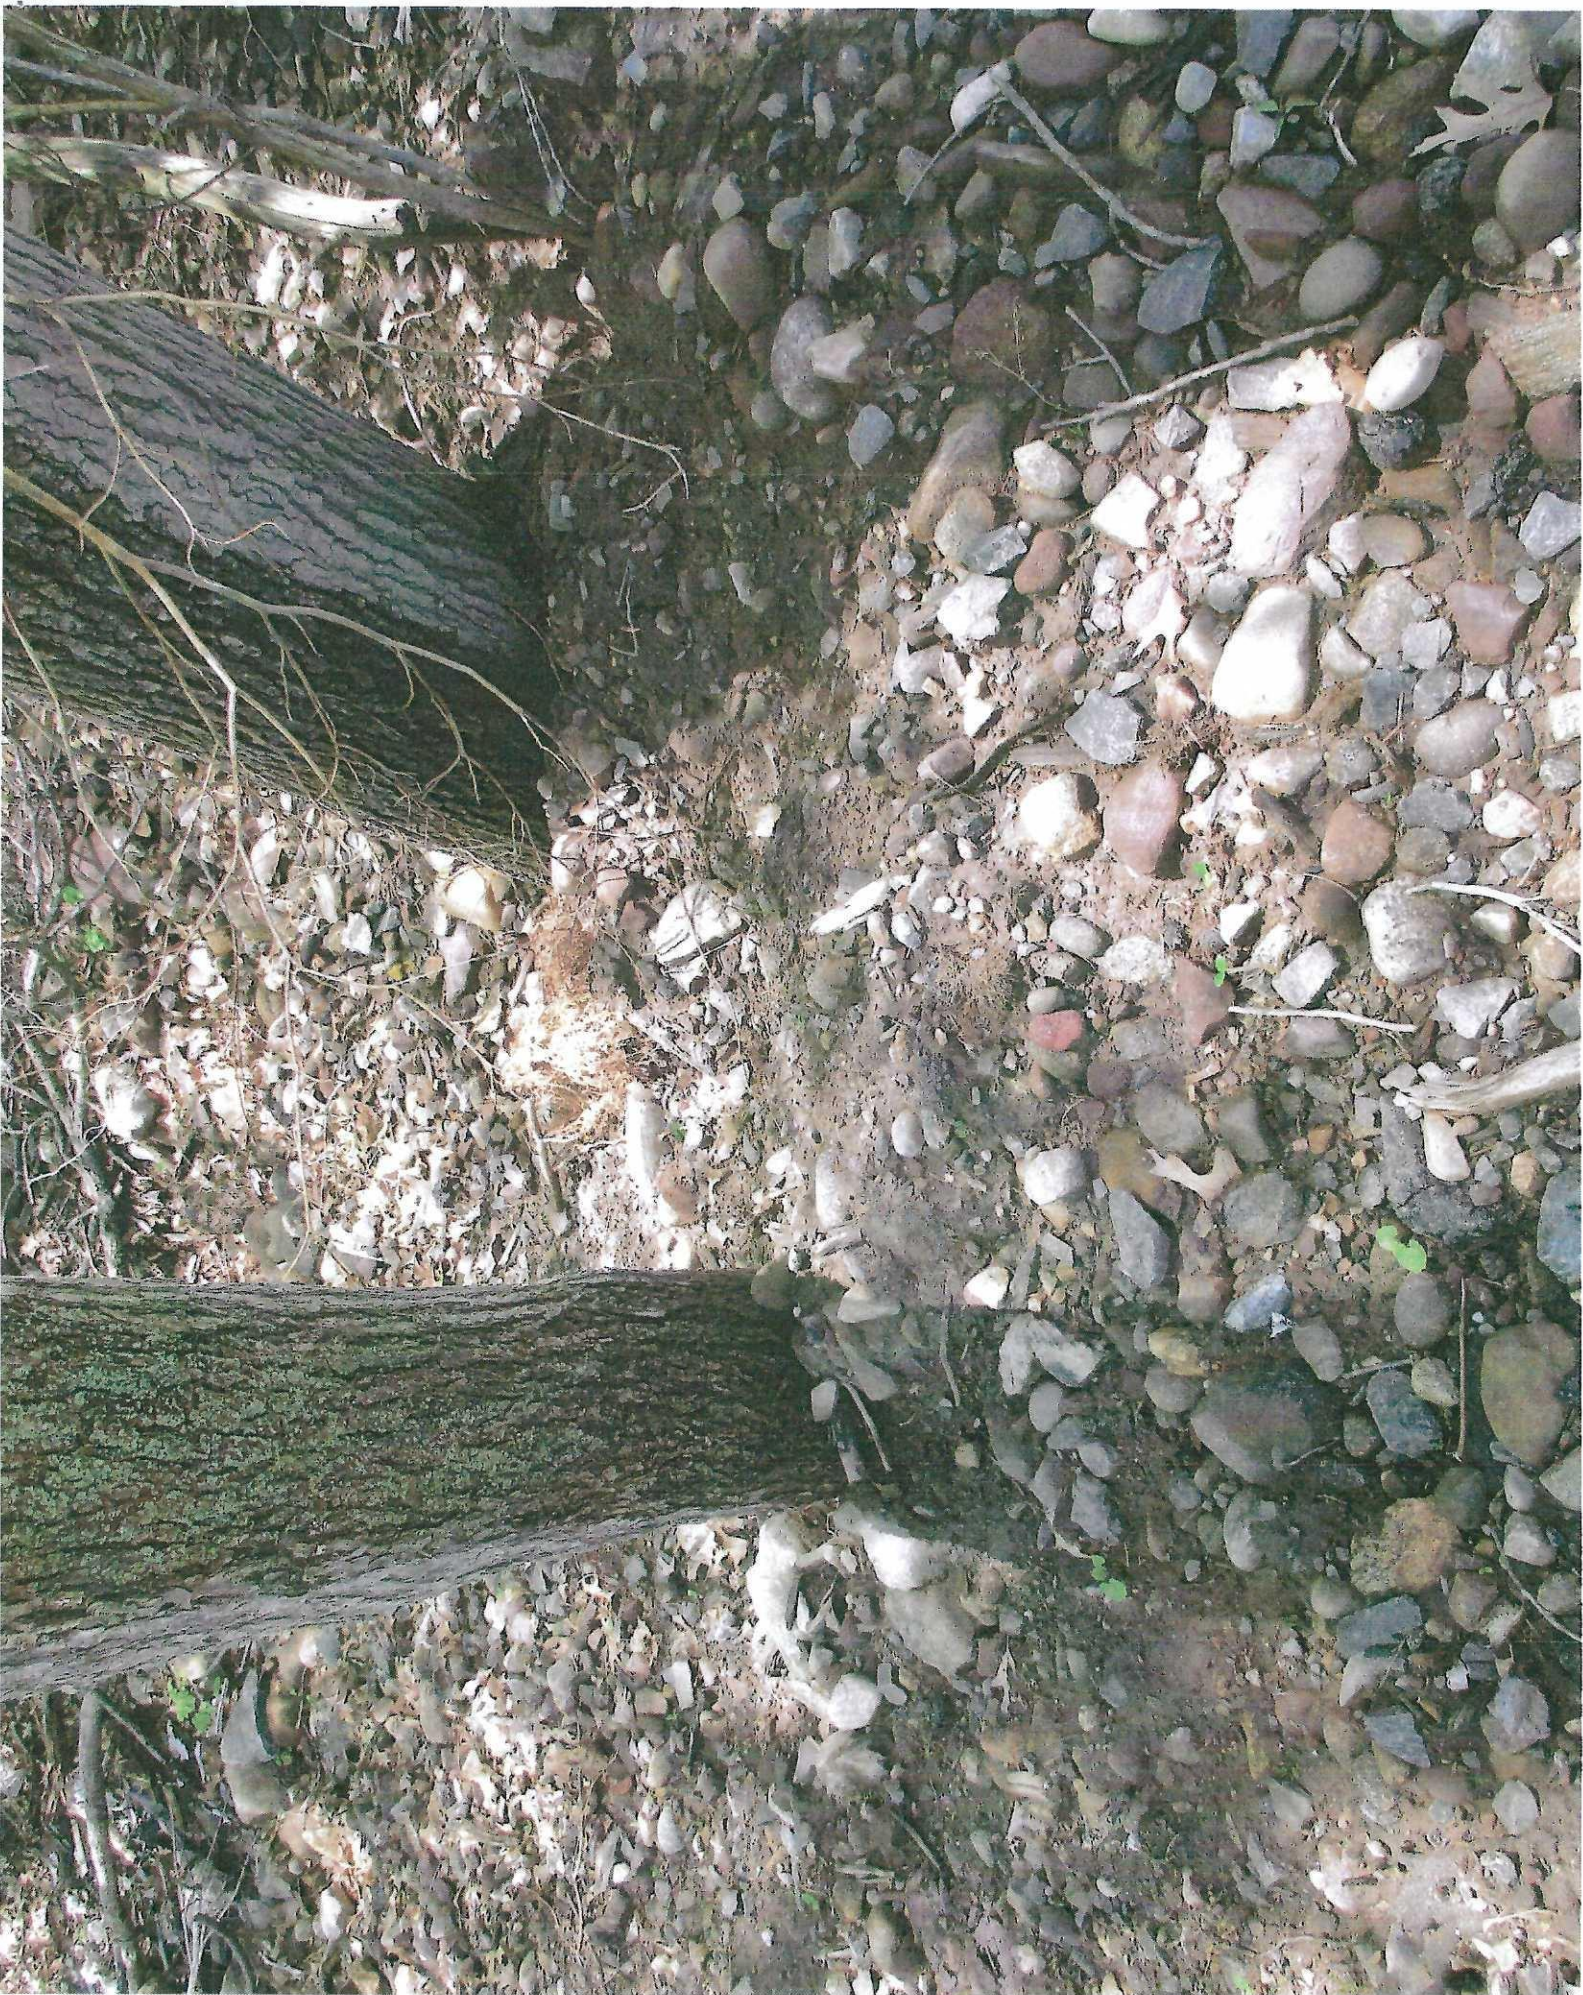
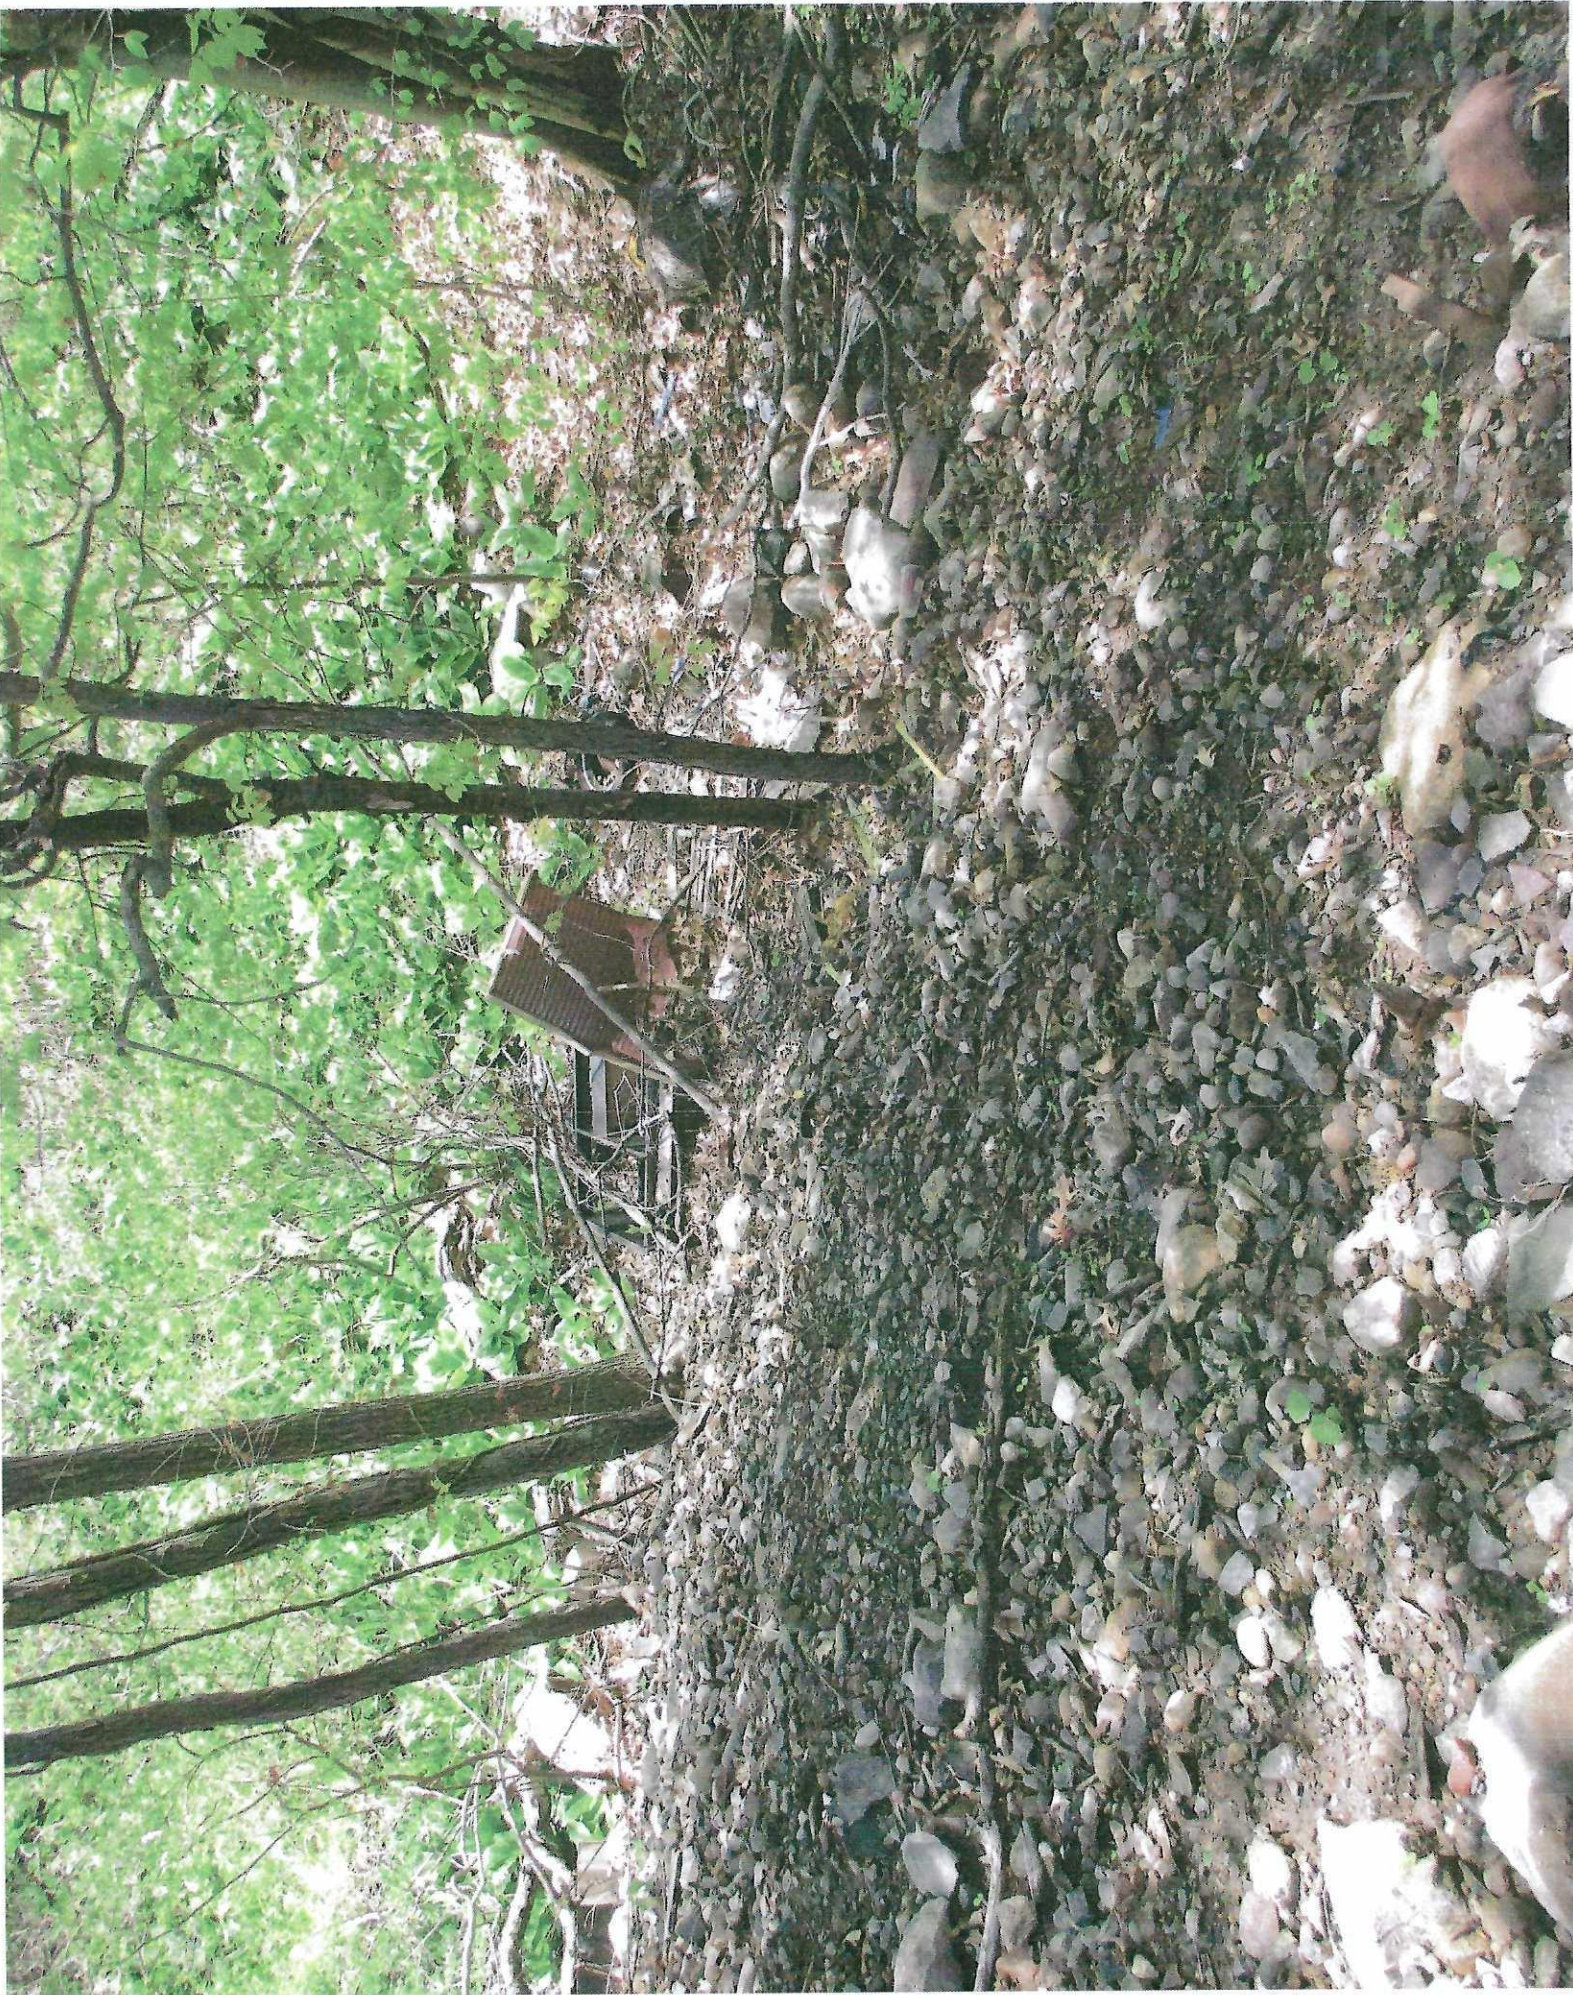
Attachment – photos taken May 15

- May 15: Fourth site investigation conducted with Acting Town Planner & Flood Manager, Tom Talbot, indicated:
 - Owner had removed much of the trash (two couches gone) but much remains at the base of the slope.
 - All fill appears to remain. Fill remains around tree trunks.
 - Surface conditions were observed to look different perhaps as a result of storms eroding away material – more dirt was observed in fill material, less dominated by rocks.
 - Photos taken (see attached)

The trees on the slope whose trunks are filled will die if this fill material is not removed soon (see photo of trunks, attached).. These trees are important as the root systems of these trees act to hold the slope together.

The IWWC should order removal of all the fill material and restoration of the slope as spelled out in detail in my previous EPR (please see – excerpt from EPR follows below). Deadlines for completion of same should be clearly stipulated in the Order. Alternatives to that action are also provided therein.
