MS4 Annual Report Transmittal Form

**For the General Permit to Discharge Stormwater
from Small Municipal Separate Storm Sewer
Systems (MS4)**

2022 MS4 ANNUAL REPORT

Town of Wallingford, Connecticut

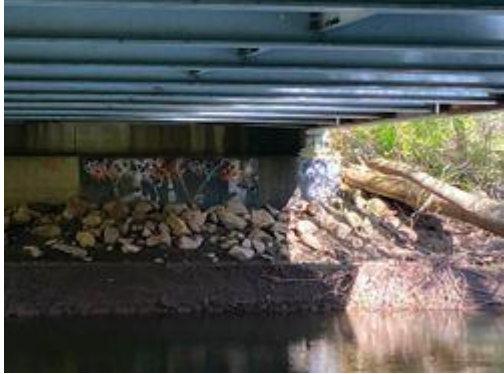
Outfall ID	
OF-194

A photograph showing an outfall structure under a bridge. The structure consists of several parallel concrete pipes. Below the pipes, there is a rocky area with some debris and a small stream of water flowing. The surrounding area is grassy and appears to be a natural or semi-natural setting.

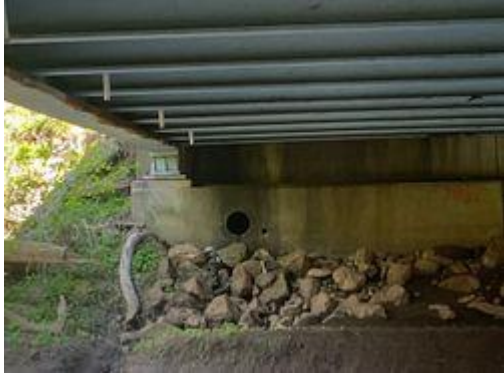
Outfall ID	
OF-195

A photograph showing a concrete outfall pipe structure under a bridge. The pipe is surrounded by a pile of rocks. The bridge structure above has several horizontal beams. The scene is outdoors with some greenery visible on the left.

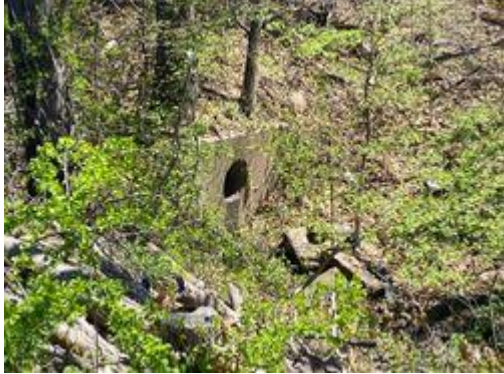
Outfall ID	
OF-205

A photograph showing a concrete outfall structure, possibly a manhole or culvert, partially obscured by dense green foliage and trees on a rocky slope. The structure has a dark, arched opening.

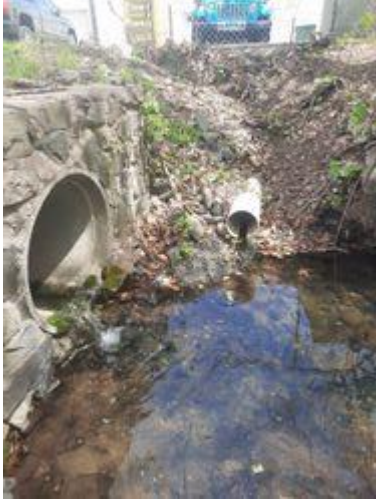
Outfall ID	
OF-136

A photograph showing a concrete outfall pipe discharging into a stream. The pipe is surrounded by rocks and debris. The water in the stream is dark and appears to be flowing over a rocky bed. In the background, there are some buildings and a fence.

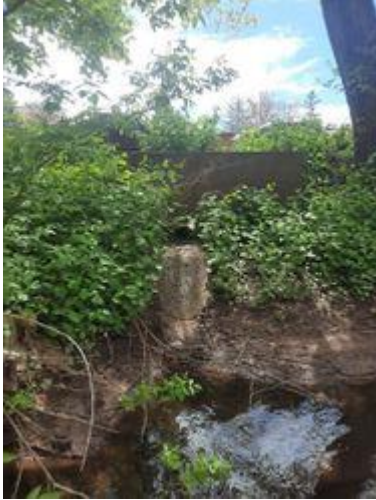
Outfall ID	
OF-142

A photograph showing a concrete outfall pipe structure partially obscured by dense green vegetation. The pipe appears to be situated in a wooded or brushy area. The water level is low, and the surrounding ground is dark and appears to be a mix of soil and roots.

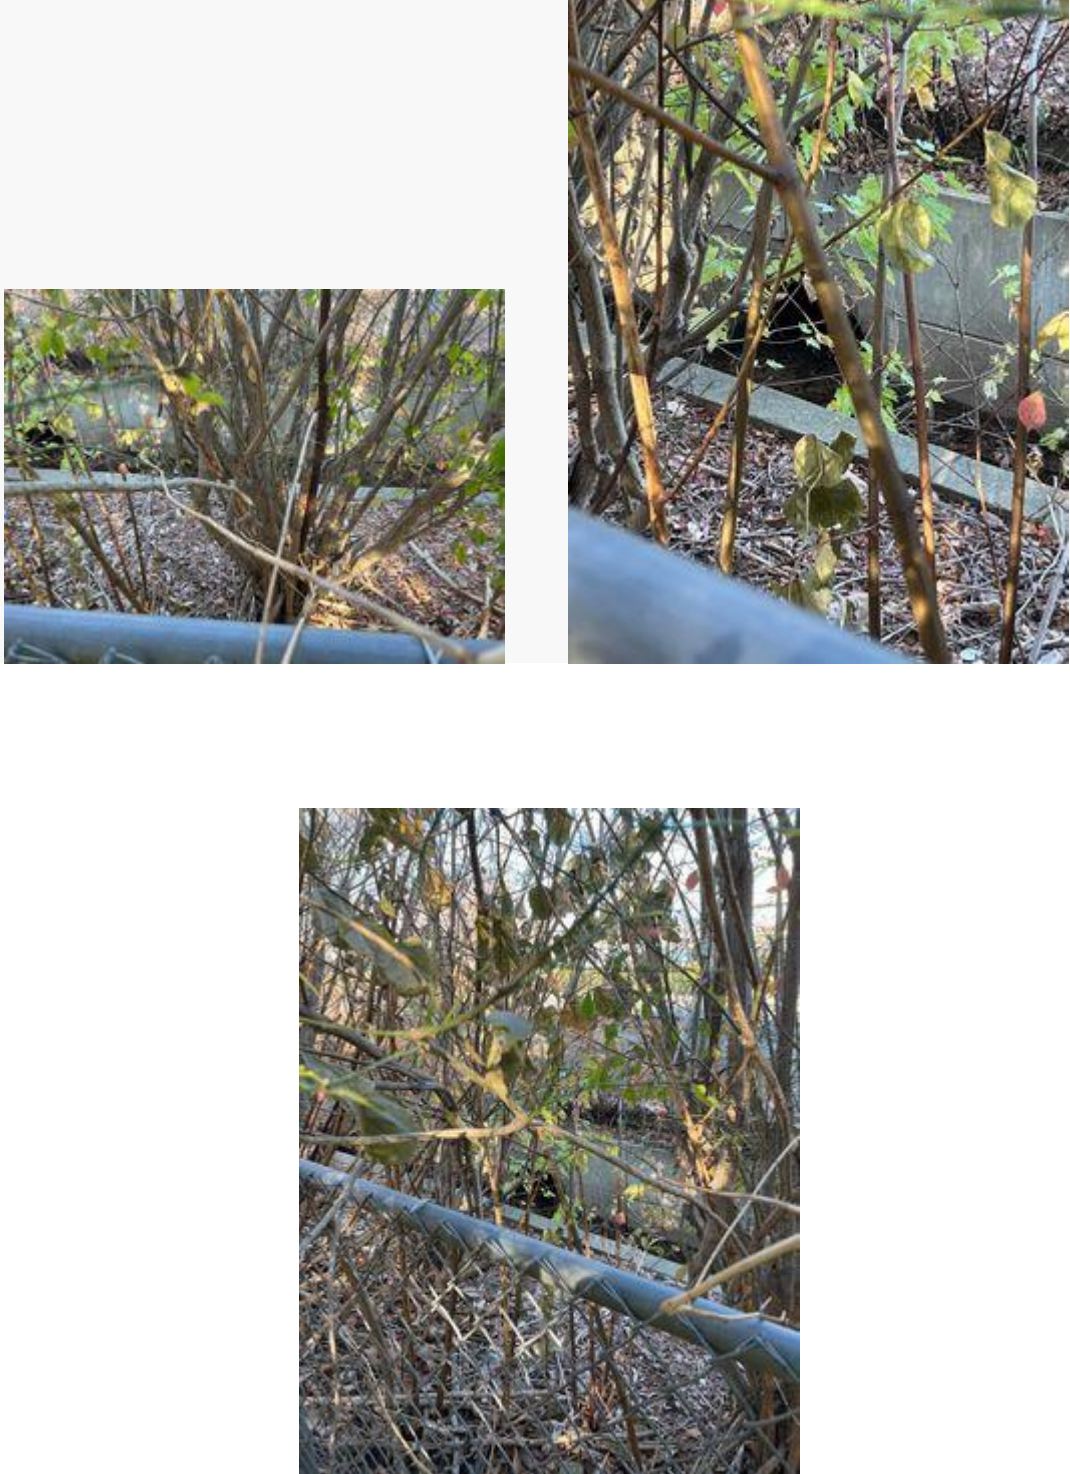
Outfall ID	
OF-518

Three photographs showing an outfall area. The top-left photo shows a dense thicket of thin, brown branches and some green leaves, with a blue pipe visible at the bottom. The top-right photo shows a similar scene with a blue pipe in the foreground and a concrete structure in the background. The bottom-center photo shows a blue pipe running through a dense thicket of branches and leaves.
