DRAFT 2025 MS4 ANNUAL REPORT

Town of Wallingford, Connecticut

February 2026

MS4 General Permit
Town of Wallingford 2024 Annual Report
Permit Number GSM 00050
January 1, 2025 – December 31, 2025
Primary MS4 Contact: Robert Baltramaitis, Director of Public Works, wallingfordtownengineer@gmail.com

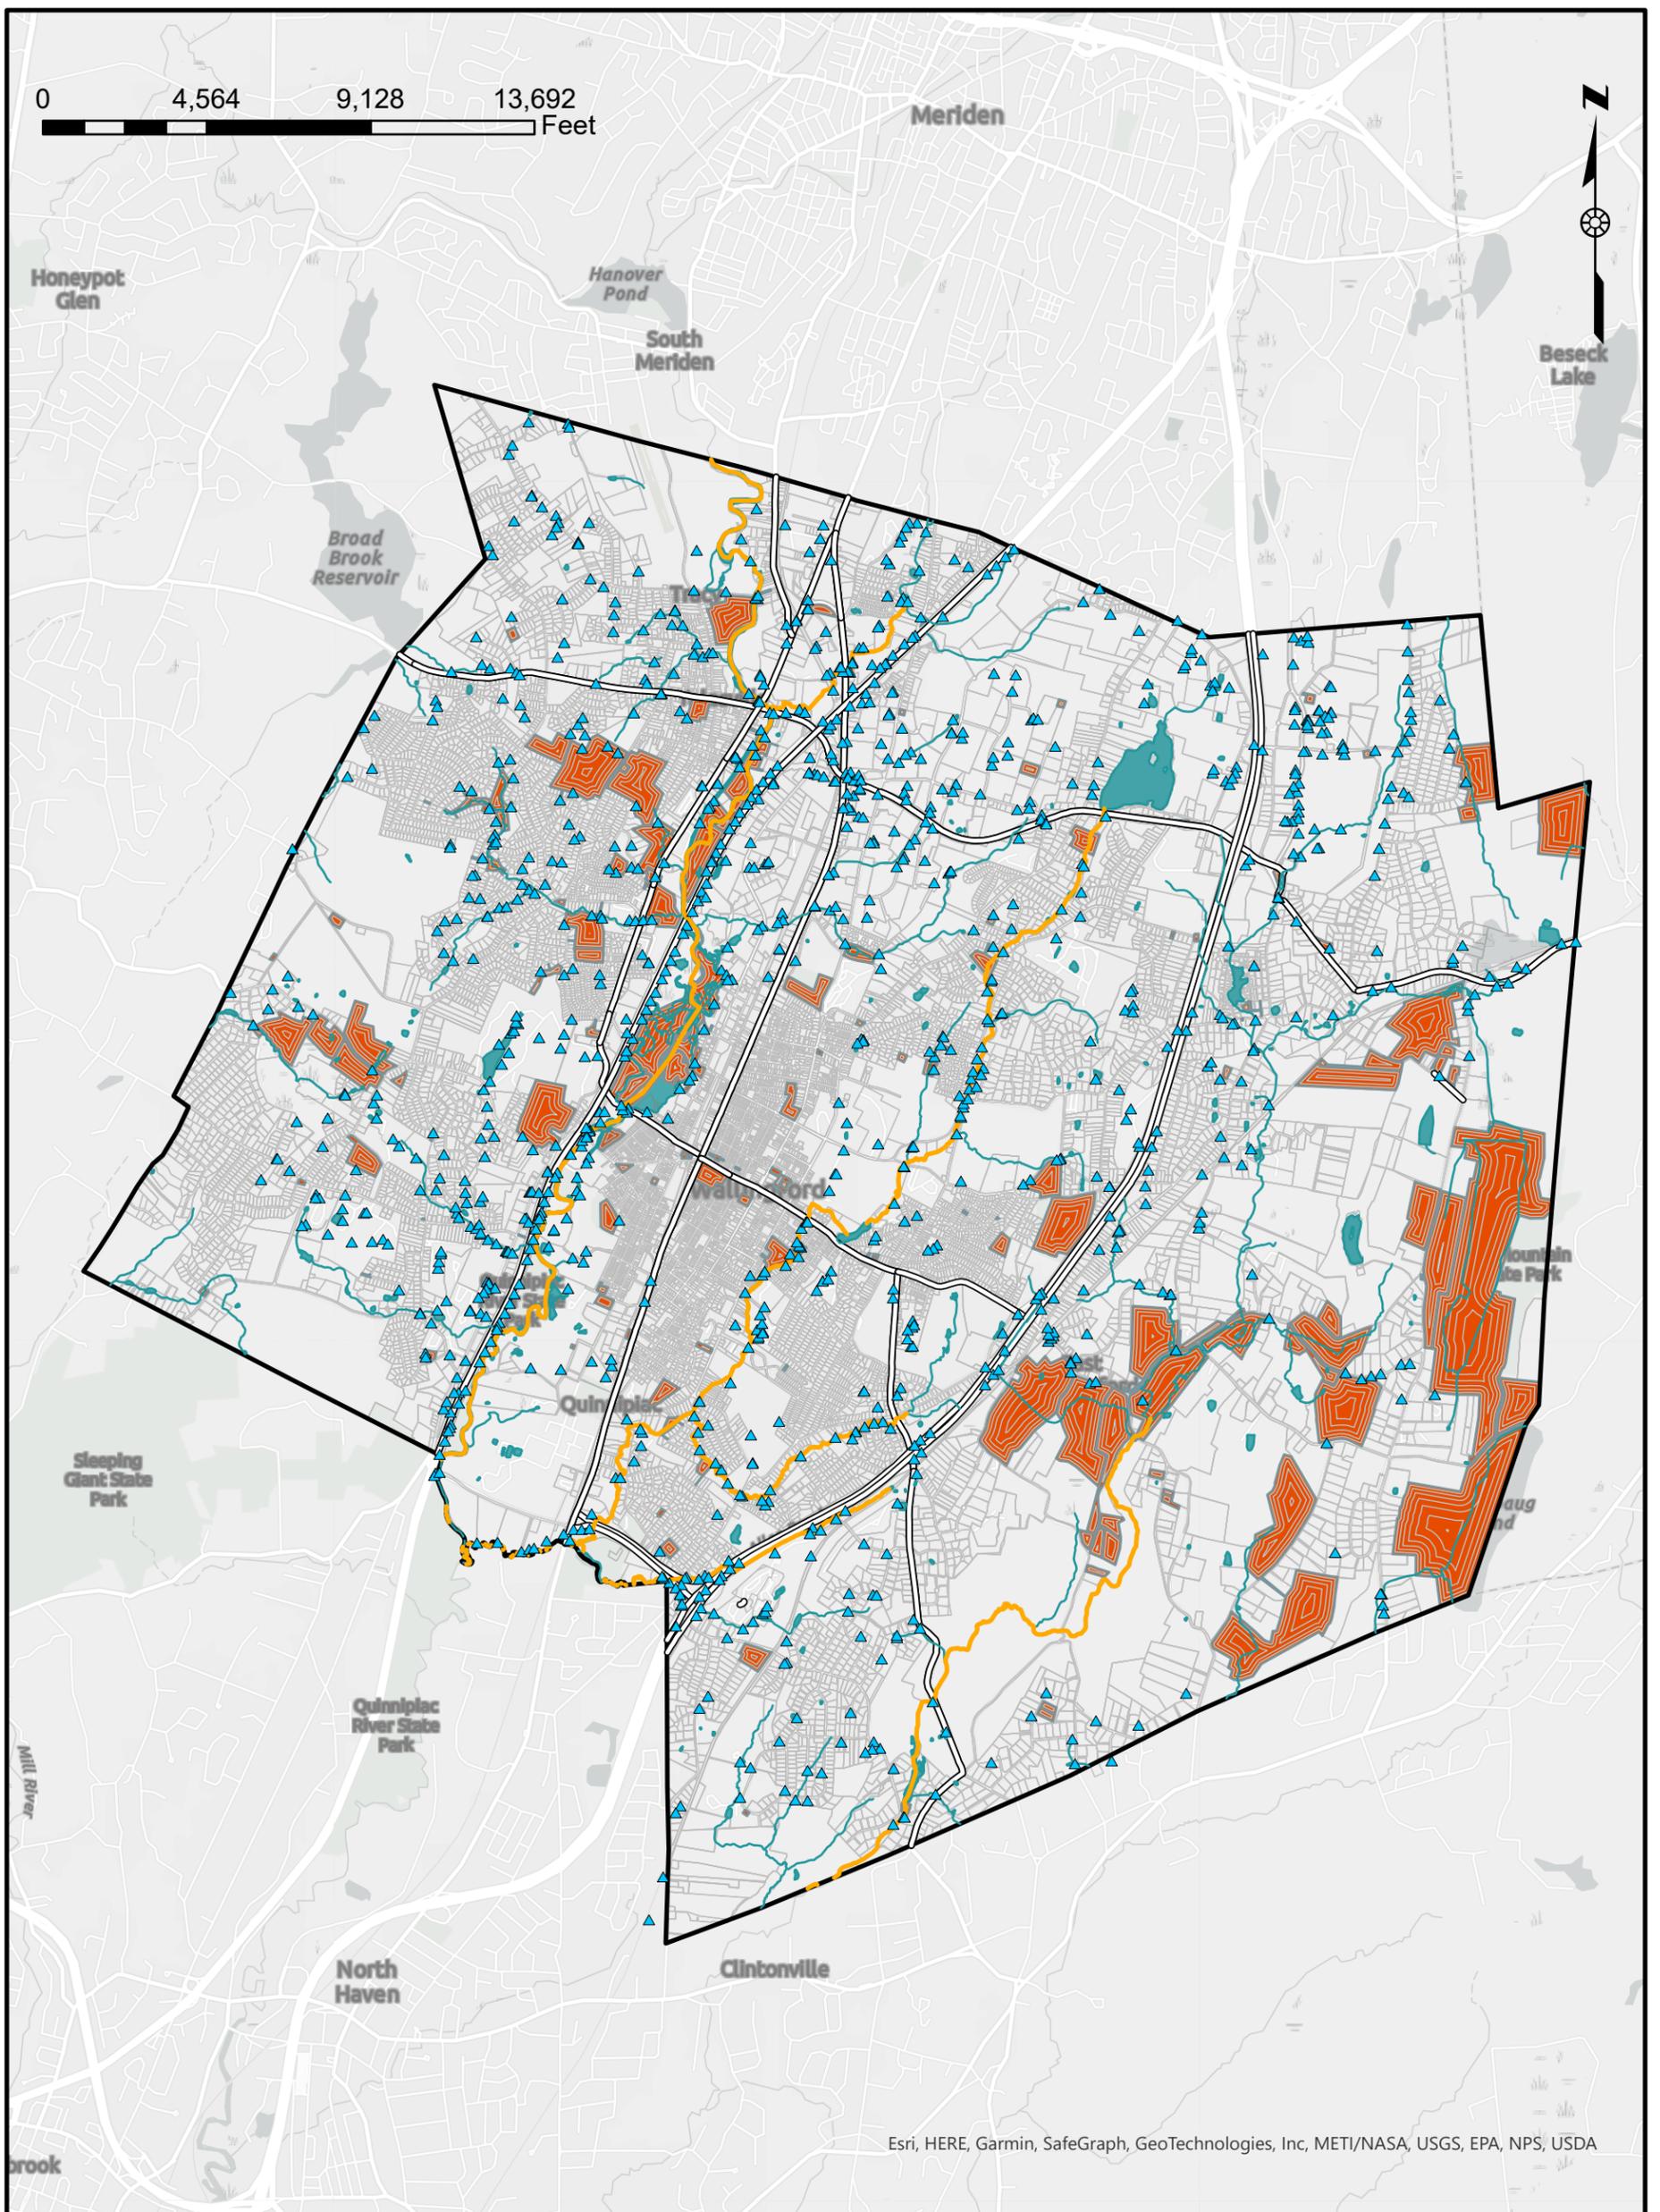
- ▲ Outfall
- Impaired Waterbody
- Surface Water
- State Road
- Town Line
- Parcel
- Town-Owned Properties

- Figure 1 – MS4 System Map
- Figure 2 – Outfalls to Impaired Waters Map
- Figure 3 – Priority Outfalls Map
- Figure 4 – Urbanized Areas by Catchment Map
- Figure 5 - Catchment Rankings
- Figure 6 – Impaired Waters by Catchment Map
- Figure 7 – Interconnections

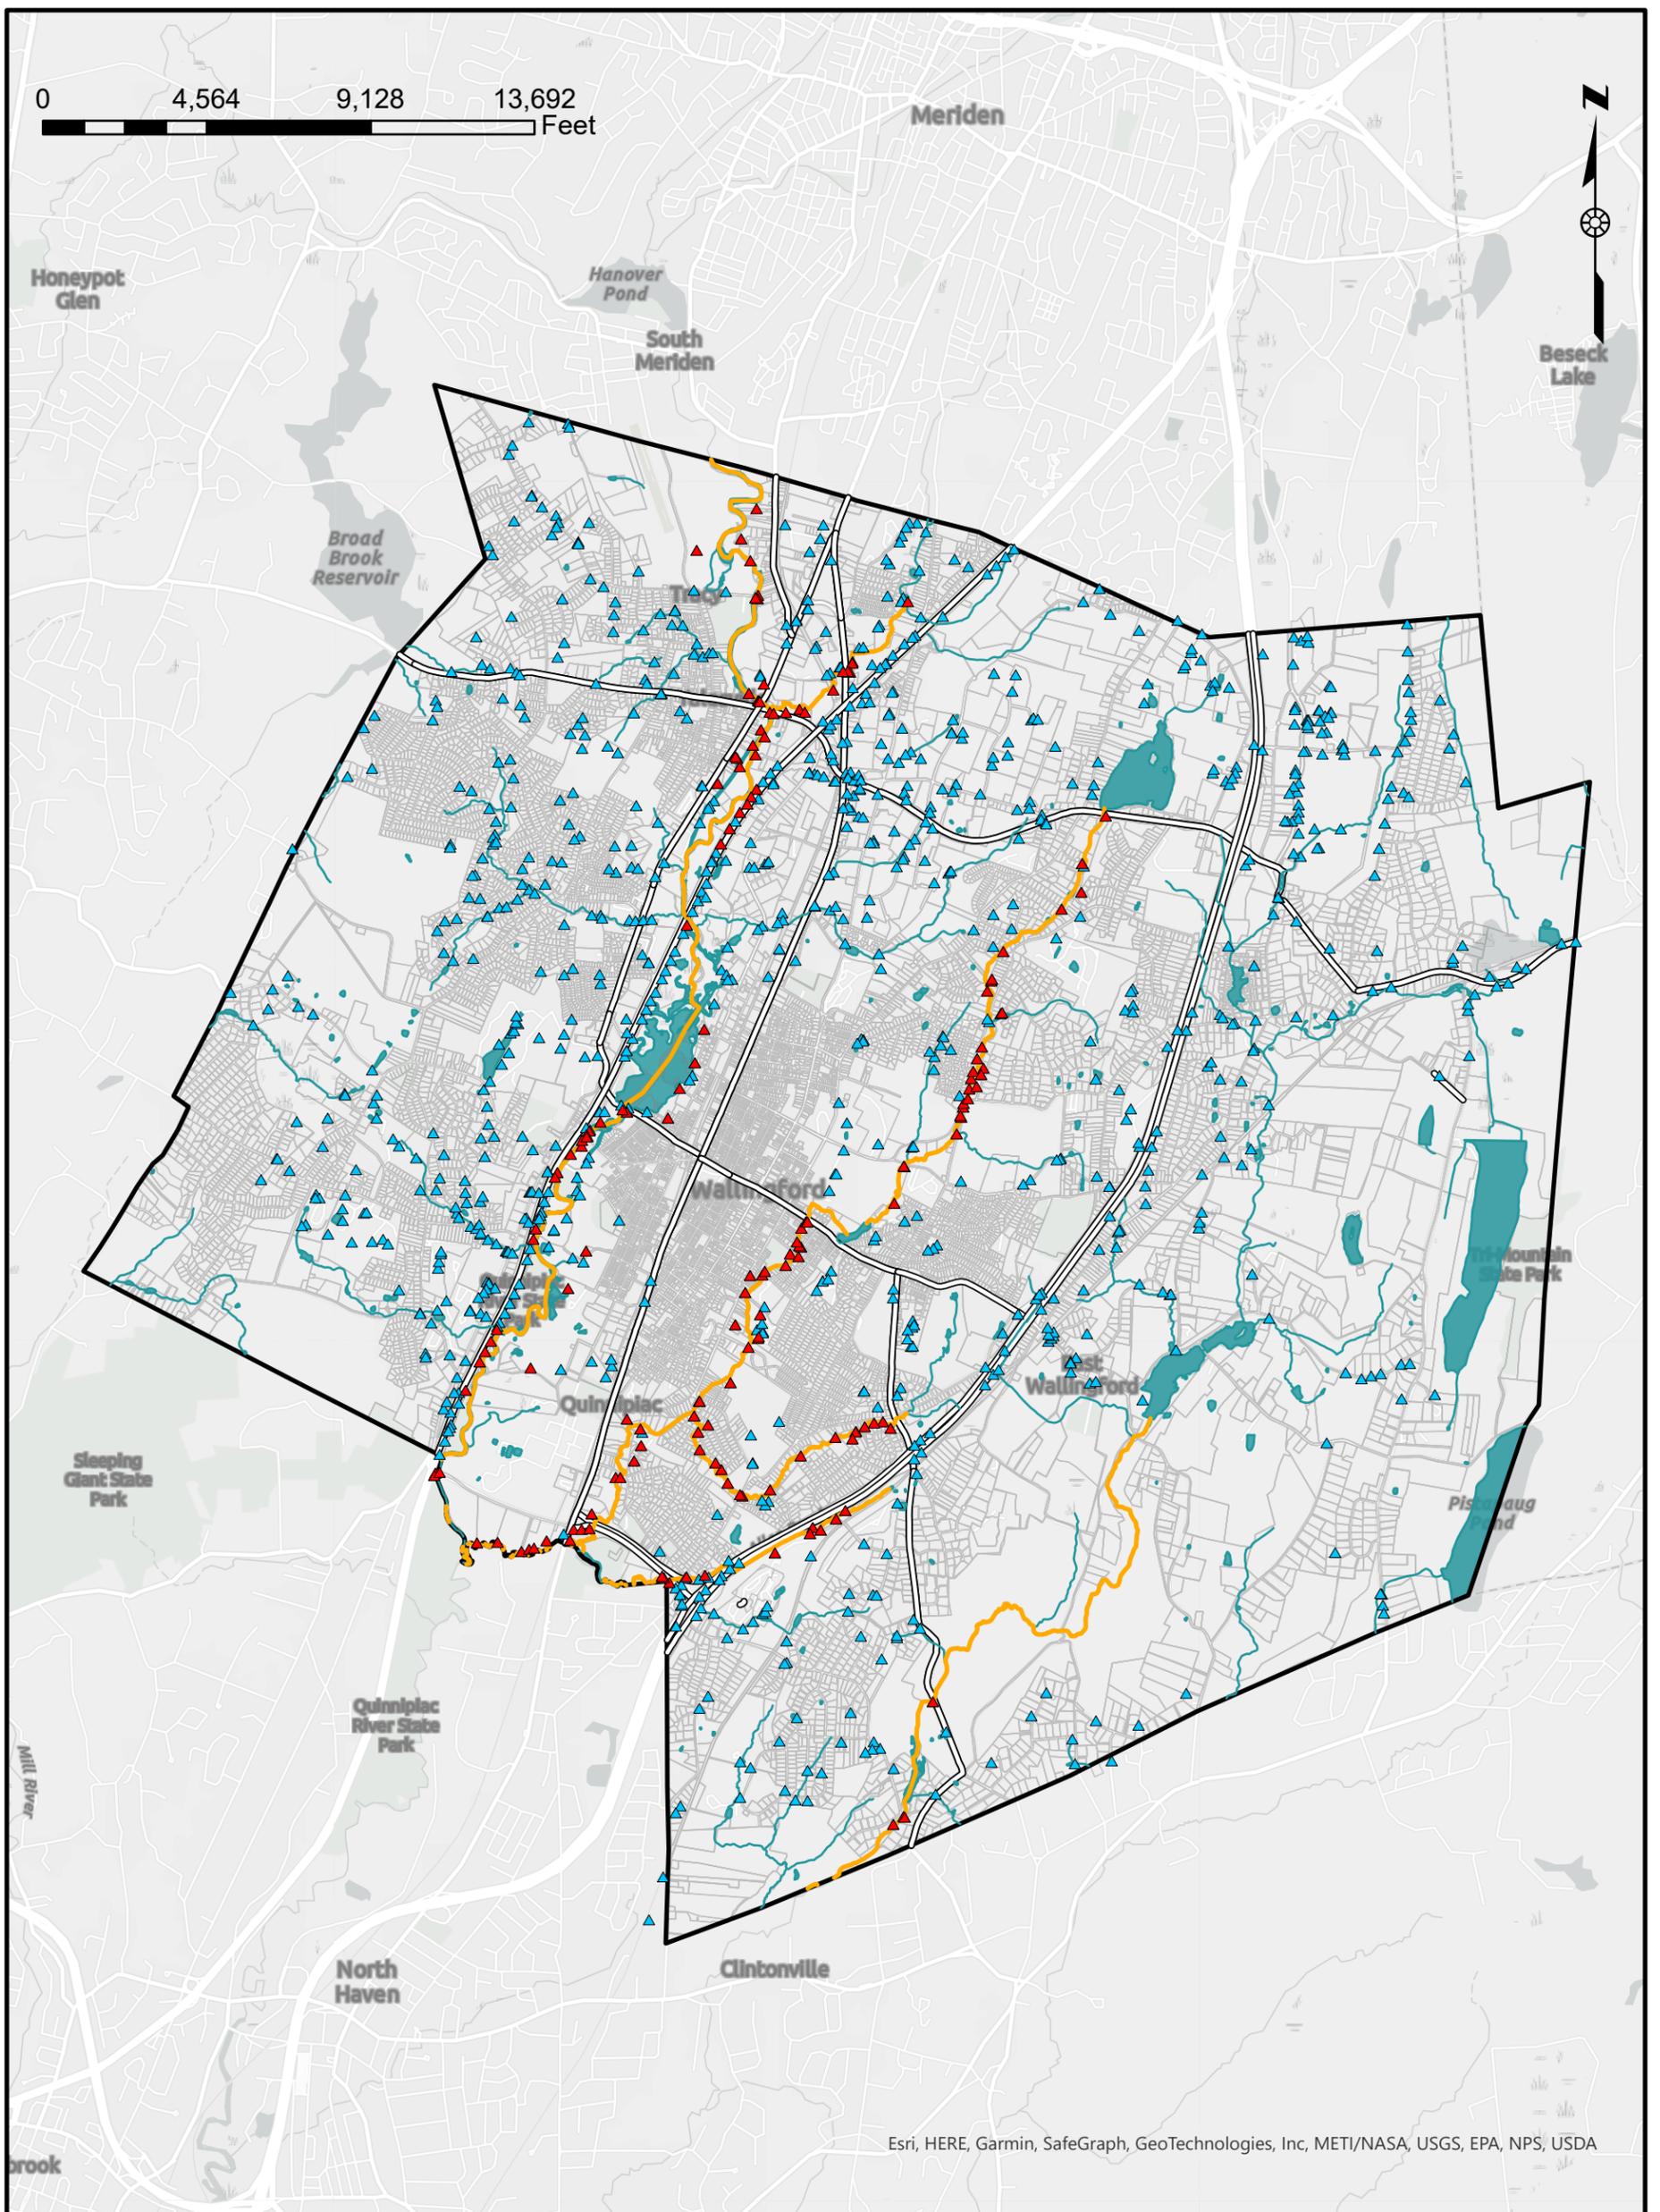
▲ Outfall	— Surface Water
▲ Outfall to Impaired Waters	— State Road
— Impaired Waterbody	▭ Town Line
	▭ Parcel

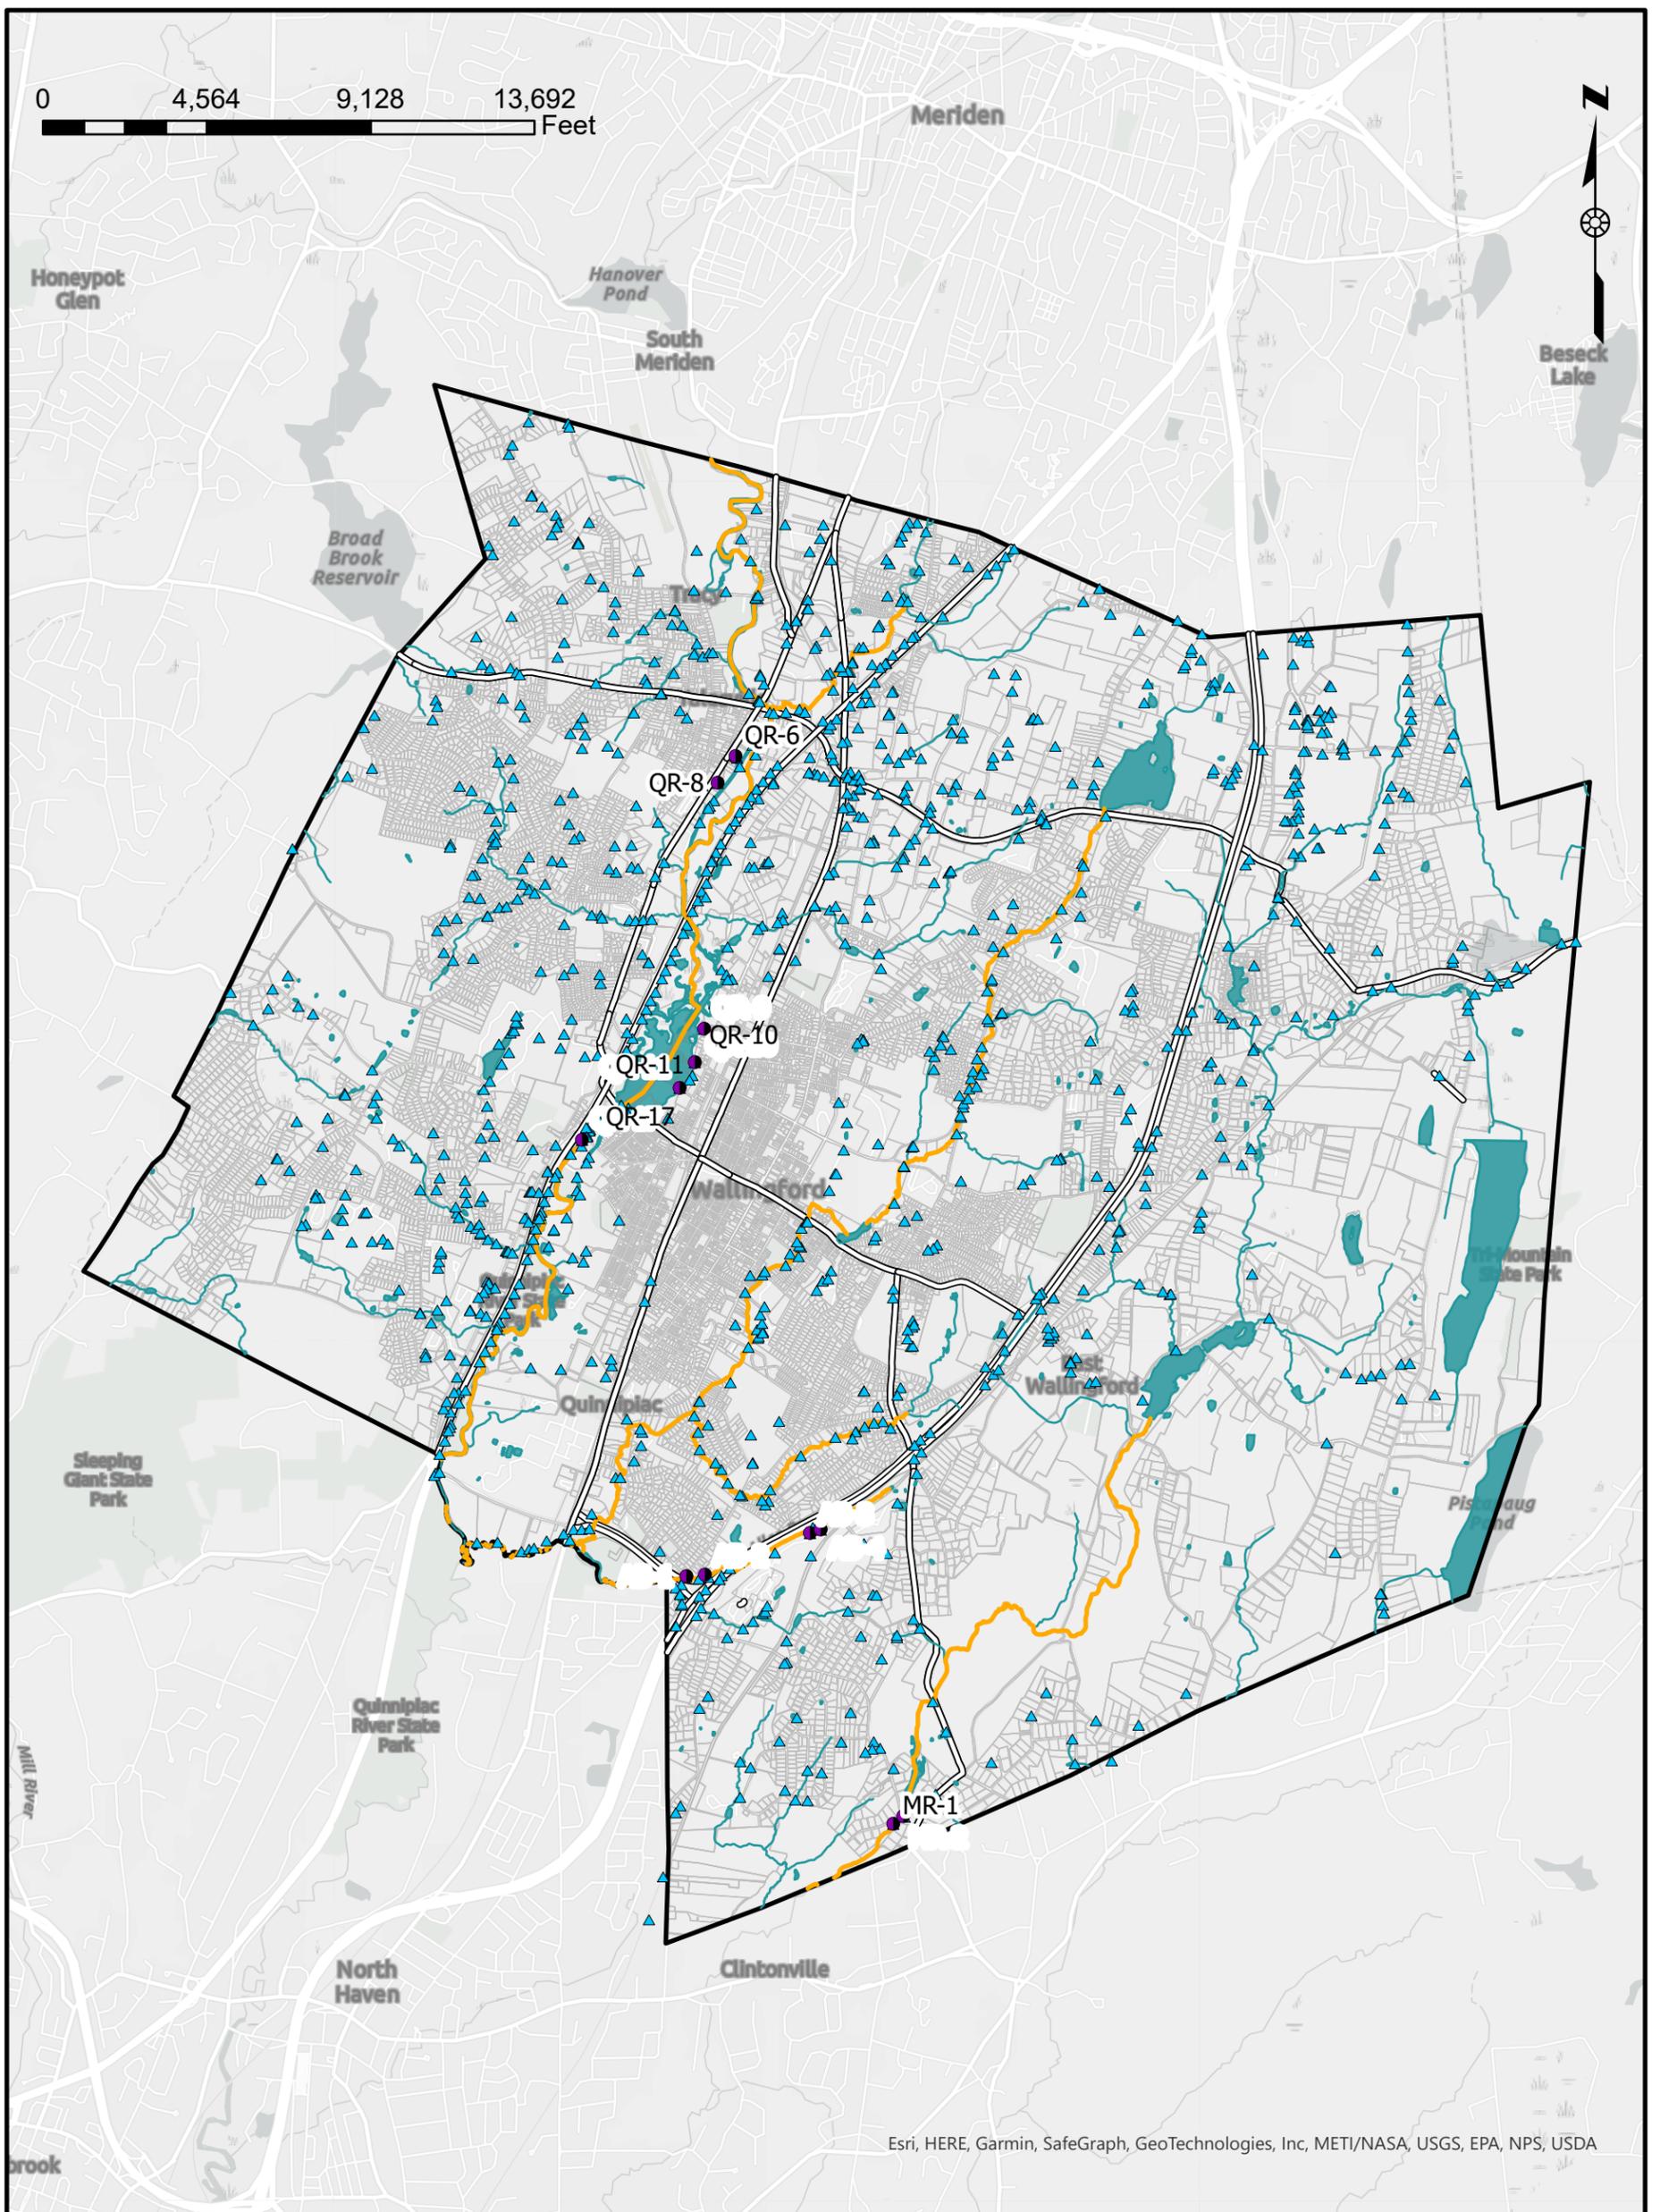
- Priority Outfall
- ▲ Outfall
- Impaired Waterbody
- Surface Water
- State Road
- ▭ Town Line
- ▭ Parcel
